## ALLSTATE HOME INSPECTIONS INC.

2007Sample.

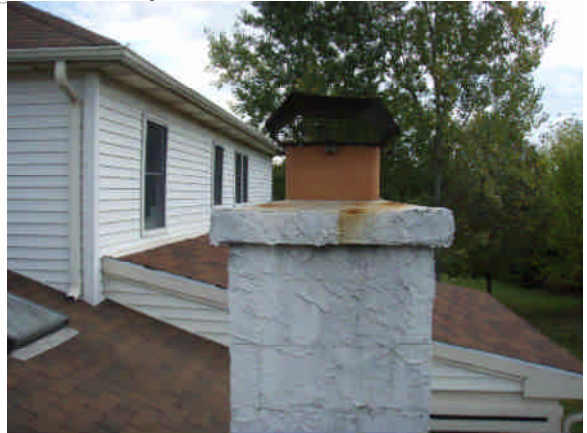
**Chimney at rear has marginal clearance above roof line. Condition appears to have caused backdrafting of chimney flue and fireplace areas. Possible safety hazard. Recommend evaluation and repair/extension as recommended by qualified chimney contractor prior to use of fireplace.**

Potential Cost of Repair \*\*\* \$1000.00 to 1500.00 \*\*\* -  
Consult with appropriate contractors for firm estimates.

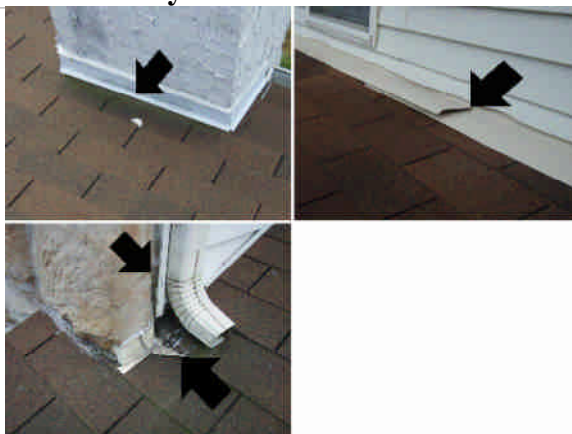
Roof materials missing at left front main roof edge. Water entry and resultant damage likely. Recommend review and repair/replacement by a qualified roofer.

Drainage diverter or "cricket" not noted at roof area(s) behind chimney(s). Area more prone to water accumulation and or entry. Staining noted at interior family room ceiling. Recommend installation of diverter to improve drainage around chimney base by a qualified roofer.

Patching noted at front lower garage roof flashing areas (juncture with second floor wall). Condition decreases reliability of juncture. Likely water entry point(s) exist. Staining at garage areas below. Recommend reflashing by qualified roofer.

Flashing(s) raised/separated at rear porch roof to house. Water entry more likely. Recommend repair and or resealing by a qualified roofer.

Potential Cost of Repair \*\*\* \$500.00 to 750.00 \*\*\* - *Consult with appropriate contractors for firm estimates.*

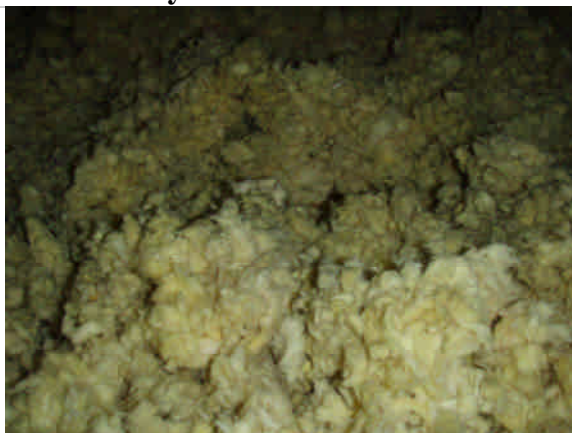
Rodent activity/burrows evident within insulation. Strong odor at master bedroom noted - possibly associated with infestation. Possible health concern. Recommend removal of existing insulation and reinsulating areas, as needed, by qualified insulation contractor.

**Rodent activity/burrows evident within insulation. Strong odor at master bedroom noted - possibly associated with infestation. Possible health concern. Recommend removal of existing insulation and reinsulating areas, as needed, by qualified insulation contractor.**

Potential Cost of Repair \*\*\* \$2400.00 to 2900.00 \*\*\* - *Consult with appropriate contractors for firm estimates.*

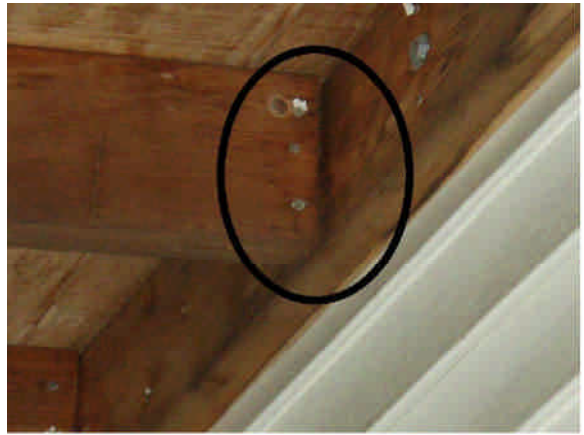
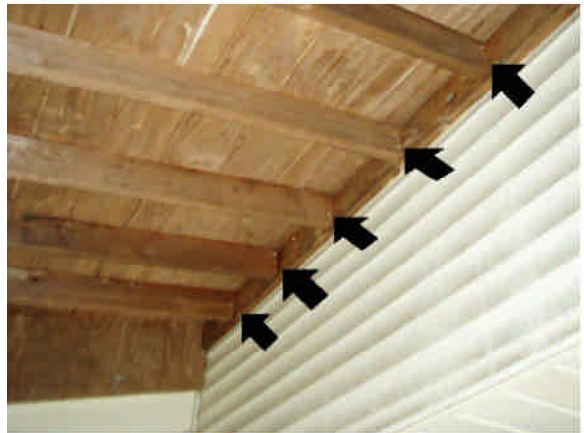
**Rear porch roof structure lacks adequate brackets/ fasteners at juncture with the home ledger board. Separation noted at several framing member connections. Possible safety/collapse hazard. Recommend evaluation and reinforcement by a qualified contractor.**

**Rear porch roof structure lacks adequate brackets/fasteners at juncture with the home ledger board. Separation noted at several framing member connections. Possible safety/collapse hazard. Recommend evaluation and reinforcement by a qualified contractor.**

Potential Cost of Repair \*\*\* \$500.00 to 750.00 \*\*\* -  
*Consult with appropriate contractors for firm estimates.*

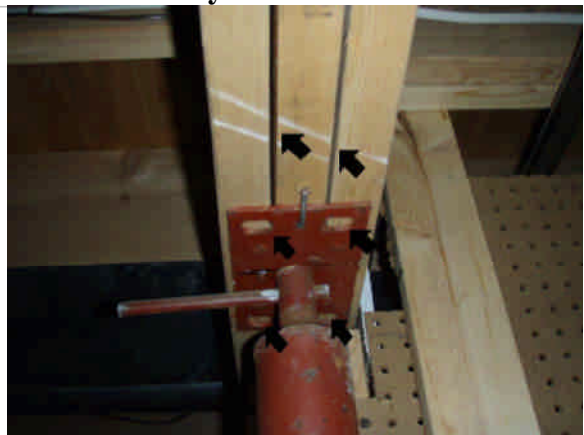
**Posts lack adequate fasteners at juncture with beam. Beam members also separating slightly. Recommend review and refastening/reinforcement by a qualified contractor.**

Potential Cost of Repair \*\*\* \$500.00 to 750.00 \*\*\* -  
*Consult with appropriate contractors for firm estimates.*

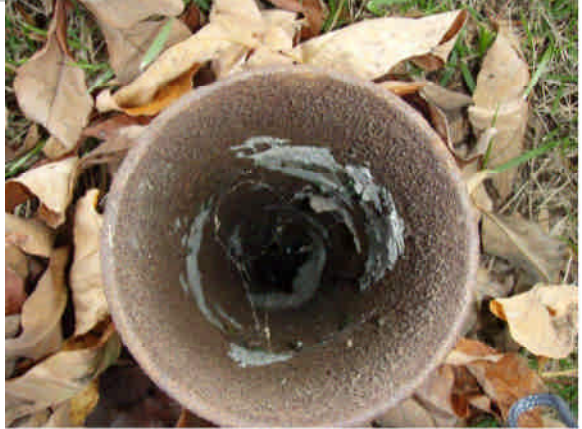
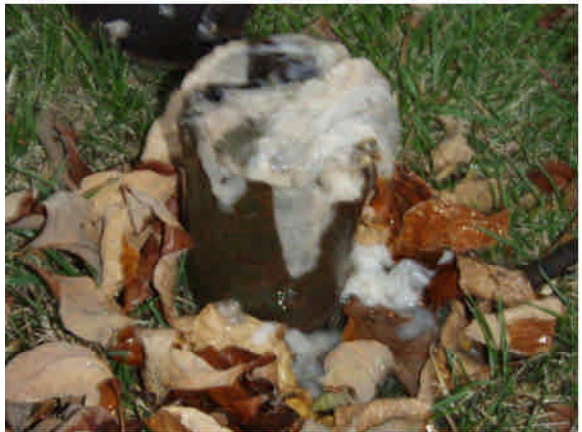
Evidence of past sewage back up and or discharge at front yard vent pipe (toilet paper stuck to inside of pipe at initial inspection of exterior). Unable to determine cause or frequency of past concerns. During operation of water fixtures and drains sewage did back up and overflow at front yard vent pipe. Recommend confirming complete disclosure of any known concerns, complete evaluation and cleaning along with video inspection/scoping and repair/replacement, if and as needed, to insure integrity and drainage by a qualified contractor.

Potential Cost of Repair \*\*\* SORRY - UNABLE TO ESTIMATE DUE TO COMPLEXITY OR STRONG POTENTIAL FOR CONCEALED CONCERNS \*\*\* - Consult with appropriate contractors for firm estimates.

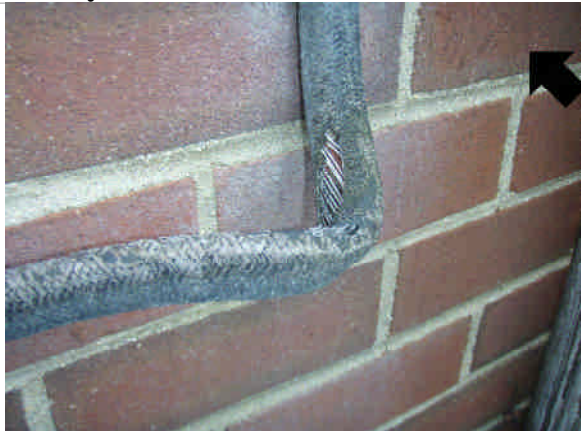
Main electric service cable frayed. Possible safety hazard. Possible fire hazard. Recommend replacement by a qualified electrician.

Potential Cost of Repair \*\*\* \$600.00 to 850.00 \*\*\* - Consult with appropriate contractors for firm estimates.
